Quality Issue #002: CDOM drift

Issue number: 2			
Contact details: chiara.monforte@voiceoftheocean.org; callum.rollo@voiceoftheocean.org			
Version	Date	Comments	Authors
1	2023-07-07	Creation of document	Chiara Monforte and Callum Rollo
2	2023-07-28	Added info on new missions: SEA069_M15; SEA077_M24 and SEA078_M14	Chiara Monforte
3	2023-08-21	Correction of a typo of flag value in the legend table	Chiara Monforte
4	2023-09-21	Added info on new mission: SEA056_M64; SEA079_M14 and SEA076_M19	Chiara Monforte
5	2023-10-06	Added info on new mission: SEA077_M25 and SEA078_M15	Chiara Monforte
6	2023-11-13	Added info on new mission: SEA079_M16	Chiara Monforte
7	2023-11-20	Added info on new mission: SEA066_M52 and SEA076_M21	Chiara Monforte
8	2023-12-07	Added info on new mission: SEA077_M28 and SEA078_M19	Chiara Monforte
9	2024-01-08	Added info on new mission: SEA076_M22 and SEA079_M18	Chiara Monforte
10	2024-01-10	Added info on new mission: SEA077_M29 and . Corrected info on mission SEA066_M52	Chiara Monforte

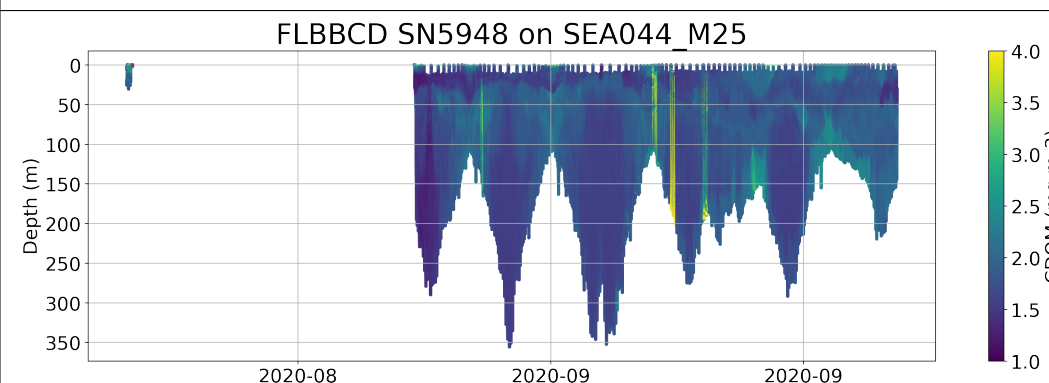
Glider	Plots
SEA044	<p>FLBBCD SN5948 on SEA044_M25</p>

<p>Comment: This mission in summer 2020 in Skagerrak showed no temporal drift. The protective copper plate was present.</p>
SEA055	<p>FLBBCD SN5925 on SEA055_M16</p>

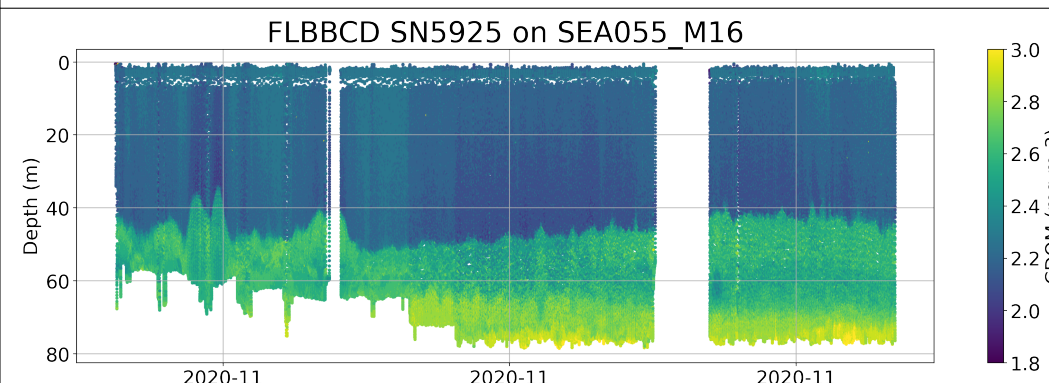
<p>Comment: This mission in late 2020 in Bornholm, where the glider surveys anoxic water, showed no temporal drift. The protective copper plate was present.</p>

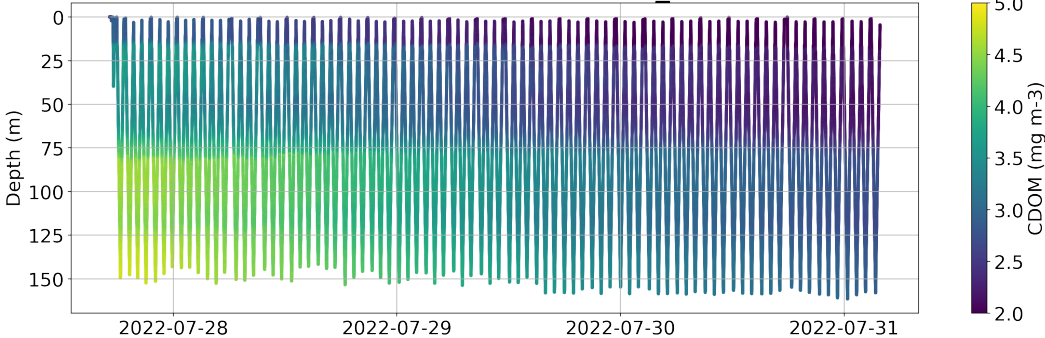
<p>SEA068</p>	<p style="text-align: center;">FLBBCD SN7564 on SEA068_M27</p>

<p>Comment: The short mission in Gotland shows an evident and rather strong temporal drift. Values decrease from 5 to 2 mg m⁻³. The protective copper plate was present.</p>
<p>SEA076</p>	<p style="text-align: center;">FLBBCD SN7485 on SEA076</p>

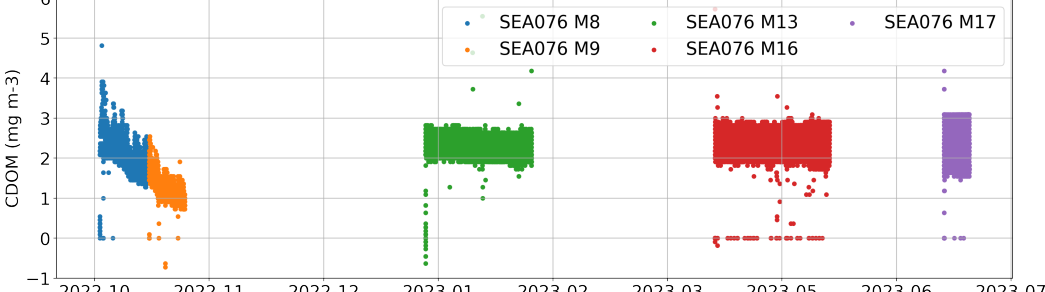
<p>Comment: The first 2 missions in Bornholm (M8-9) show an evident temporal decrease in CDOM concentration. The protective copper plate was removed (M13-16-17 in Gotland) and data shows no temporal drift. All those missions surveyed anoxic areas.</p>
<p>SEA077</p>	<p style="text-align: center;">FLBBCD SN7522 on SEA077</p>

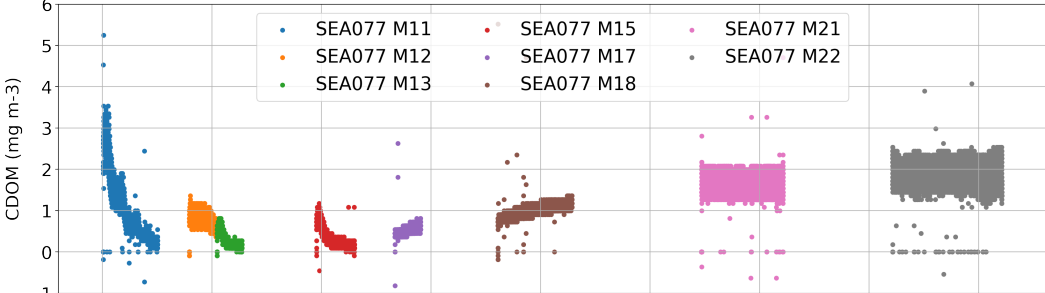
<p>Comment: The first 4 missions (M11-12-13-15) show an evident temporal decrease in CDOM concentration. The protective copper plate on the sensor was removed before the start of mission 17 (in purple in Figure 1). The first two missions after the copper plate is removed (mission 17-18) show a temporal increase instead. Finally, the last two missions (21-22) show no temporal drift. All those missions surveyed anoxic areas.</p>

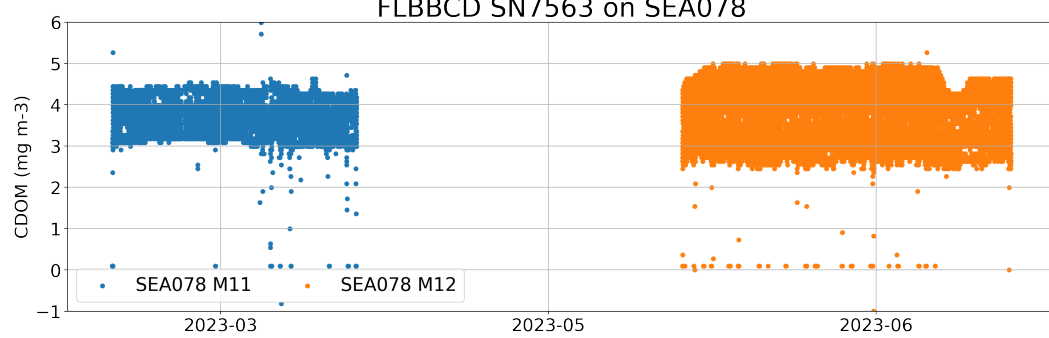
<p>SEA078</p>	<p style="text-align: center;">FLBBCD SN7563 on SEA078</p>

<p>Comment: The protective copper plate was removed before the first deployment. Data never showed a temporal drift. All those missions surveyed anoxic areas.</p>
<p>SEA079</p>	<p style="text-align: center;">FLBBCD SN7619 on SEA079</p>

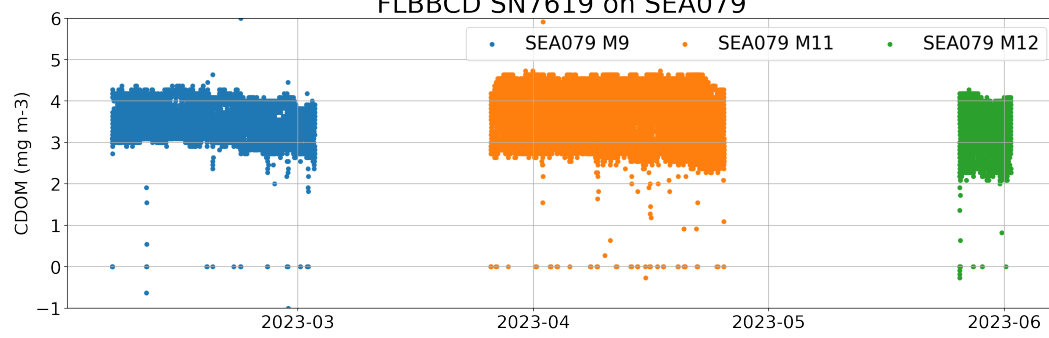
<p>Comment: The copper plate protecting the sensor was removed before the first deployment of the glider. Data has never showed a temporal drift. All those missions surveyed anoxic areas.</p>
